Inspection Report

Mine Name: Torrey Buff

Permit number: S/055/022

Inspection Date: May 12, 2005

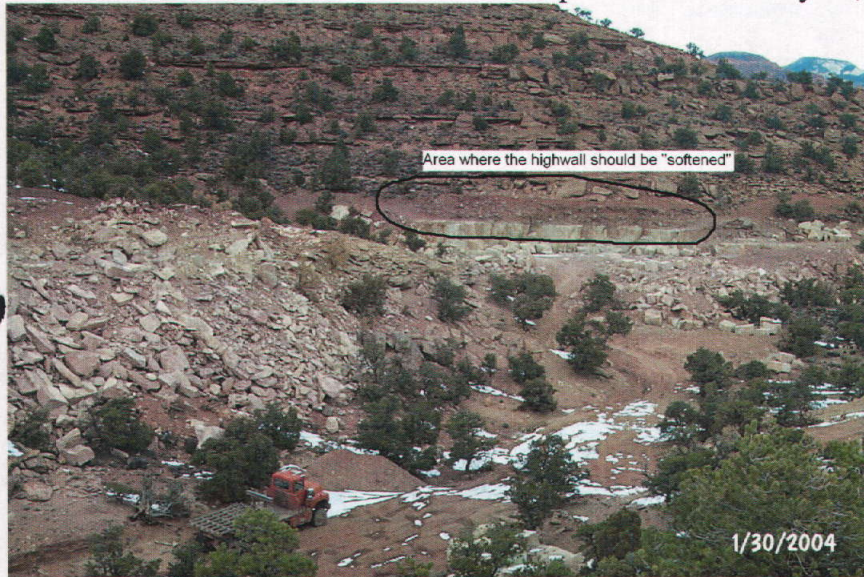
3. Photo 1 shows a portion of the northwest part of the quarry. Some reclamation grading has been done in this area since the picture was taken. The photo shows an area above the highwall that needs to be "softened" by bringing down some of the material from above.

Photo 1. The circled area is where we agreed some material should be pulled down from above to "soften" the highwall.

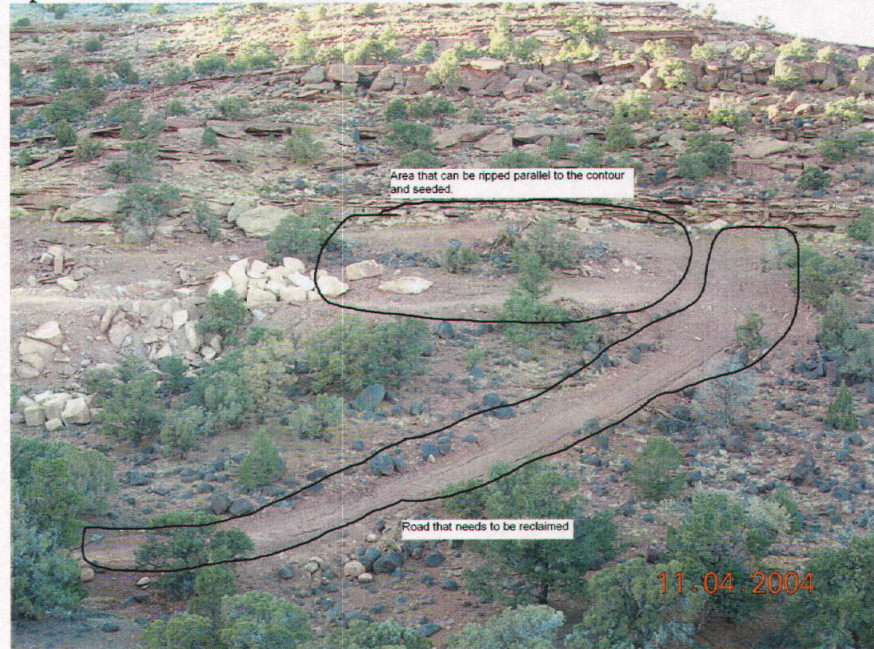
4. Also in the northwest part of the quarry, there is an area that can be ripped parallel to the contour and seeded (center portion of Photo 2). This should be done in the fall.

5. There is a road on the north side of the northwest portion of the quarry (Photo 2). This road should be reclaimed by putting in periodic water bars or other erosion control features. It should then be seeded. This work should all be done in the fall.

Photo 2. Two areas in the northwest part of the disturbed area that need additional reclamation work. The upper area should be ripped on the contour and seeded, and the road needs erosion control (water bars) and to be seeded.
